Department of Civil Engineering

COBUTE
P.O. Box 265
Melkbosstrand
7437

Report on structural tests on reinforced concrete beams – Testing of different beam systems

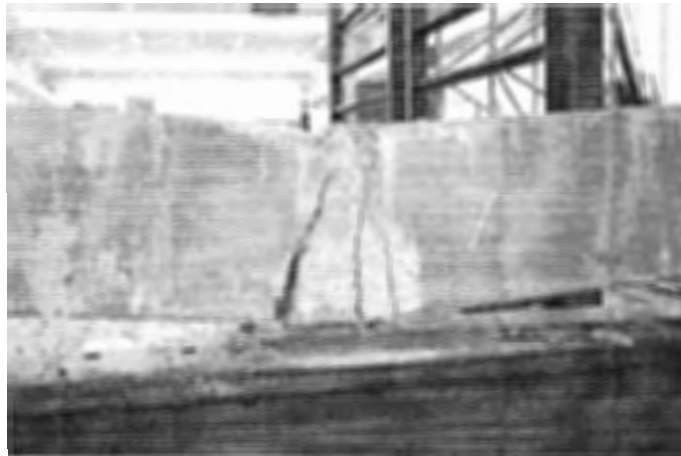
Figure 6: Beam 7 (COBUTE 1) after failure in bending

Figures of beams 7 (COBUTE 1), 13 (COBUTE 2) and 16 (COBUTE 3) after failure are presented in Figures 6-8. All beams showed the typical bending failure that can be expected to happen with monolithic beams.
